Manhole Inspection Summary

Manhole # S39A__001MH

Insp Date: **11/19/08 9:49 AM**

Location Address: **side 1016 monument st**

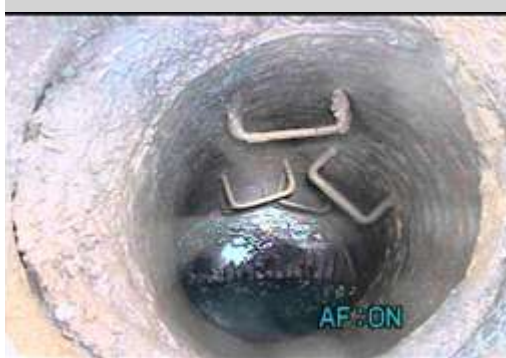
Defect 3

Infiltration: ☐ None ☒ **Joint** ☐ Cracks ☐ Mortar ☐ Roots ☐ Wall

Count: **6** Missing: **0** ☒ **Corroded**

chimney infiltration, corr steps

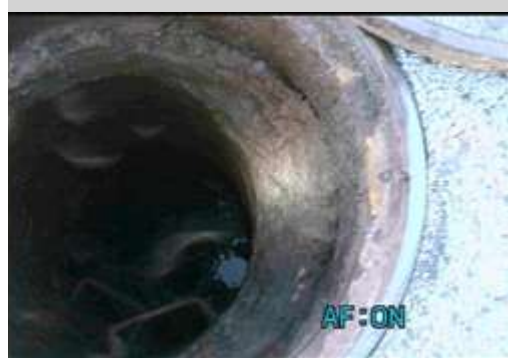
Defect 2

Offset: **5** (in.)

offset

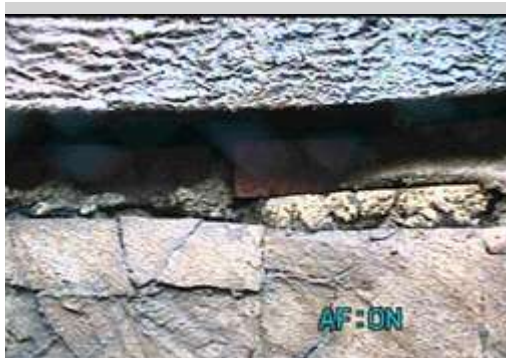
Defect 1

Condition: ☐ Sound ☒ **Cracked** ☐ Root Intrusion ☐ Loose Brick ☒ **Deteriorated**

chimney cracked, loose bricks, frame adj

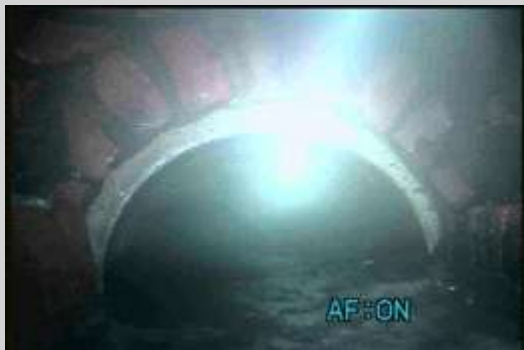
12 O'Clock Outflow

too steamy to see in pipe
